Contract No. EP/SP/66/12
Integrated Waste Management Facilities, Phase 1

CORAL TRANSLOCATION PLAN

(Clause 2.12, Further Environmental Permit FEP-01/429/2012/A)

KSZHJV	/	312	/	EPR	/	0001	/	E
Issuer		Project Code		Type of Document		Sequential No.		Revision Index

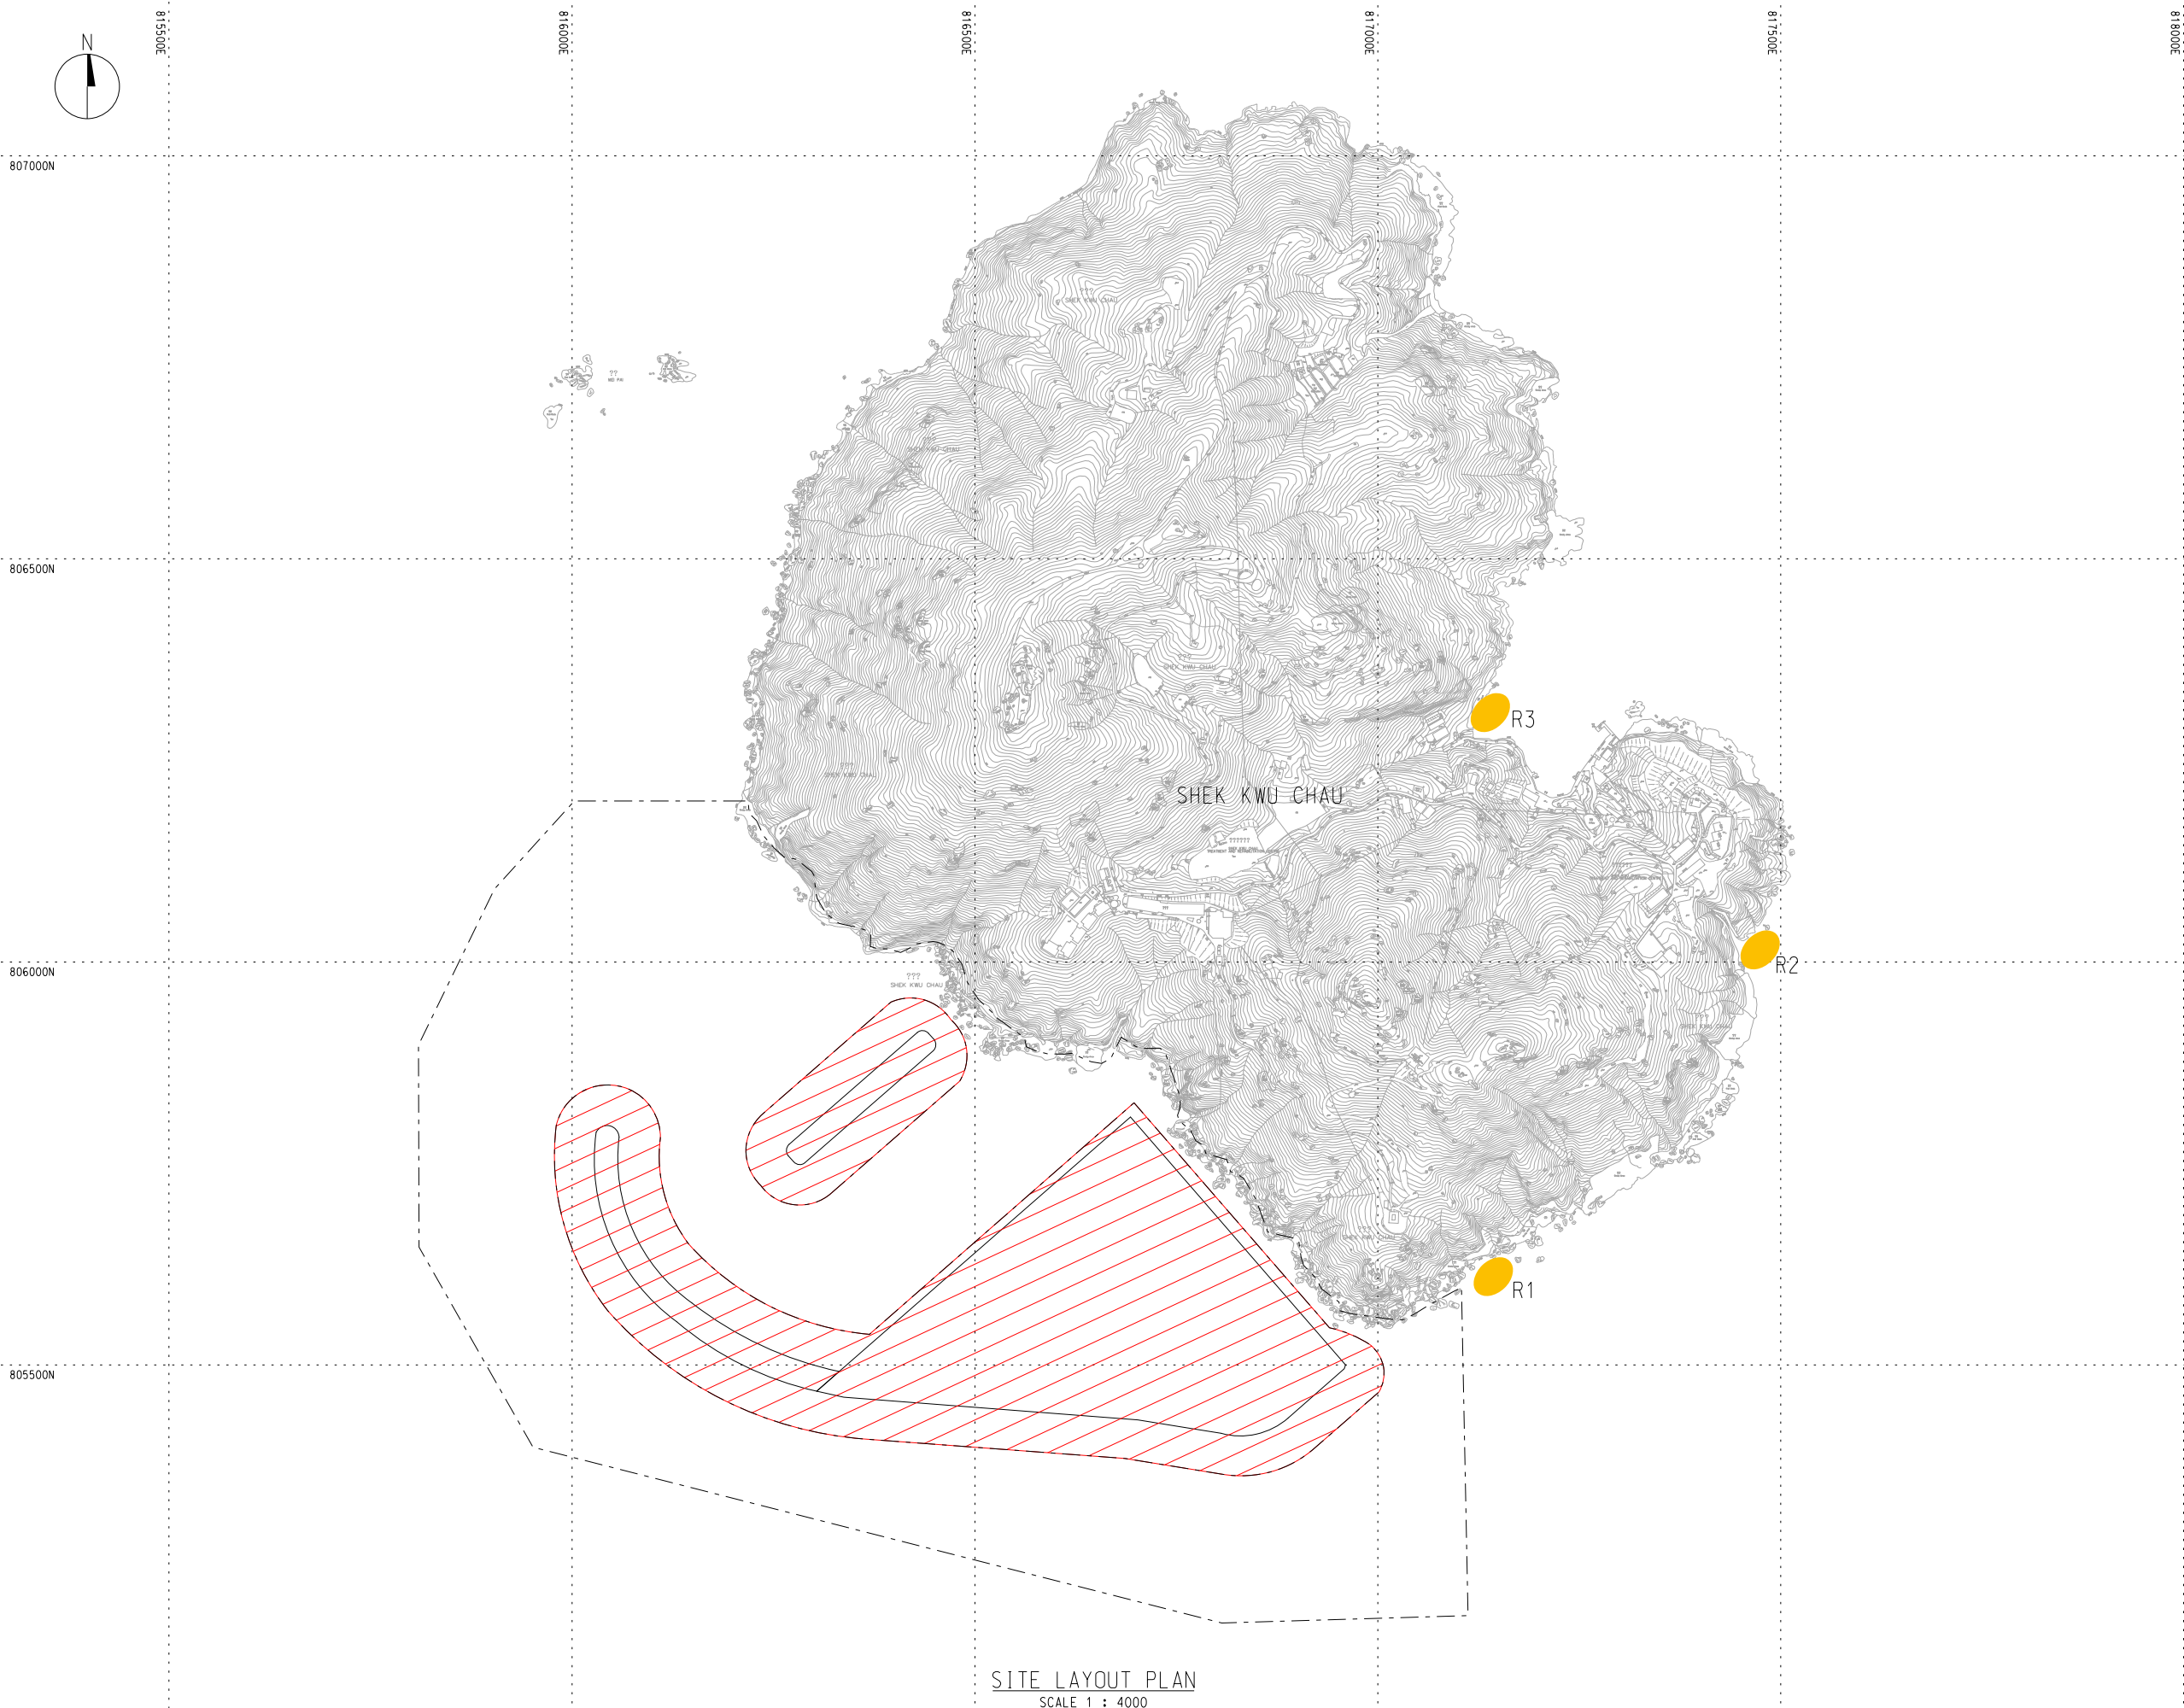
Figure 1 Pre-Translocation Survey Area and Proposed Recipient Sites R1, R2 and R3

TITLE			INTEGRATED WASTE MANAGEMENT FACILITIES PHASE 1 PROPOSED RECIPIENT SITES R1, R2 AND R3		
SCALE @ A1	DRAWING NO.	REV.			
1 : 4000	EP/SP/66/12/COR/004	A

- 3.2.1. The Spot-Check and REA surveys were performed in January and February 2018 for potential Recipient Site R1, R2 and R3 (**Figure 1**); and the weather conditions were summarized in **Table 3.2**. Spot-Check surveys were conducted along the hard substrate of the three proposed recipient sites at the south-eastern and eastern coast of SKC. 4 species to 7 species of coral were recorded during the spot-check surveys in the three potential recipient sites (**Table 3.3**). Following the spot-check survey, REA survey was conducted at the same date.

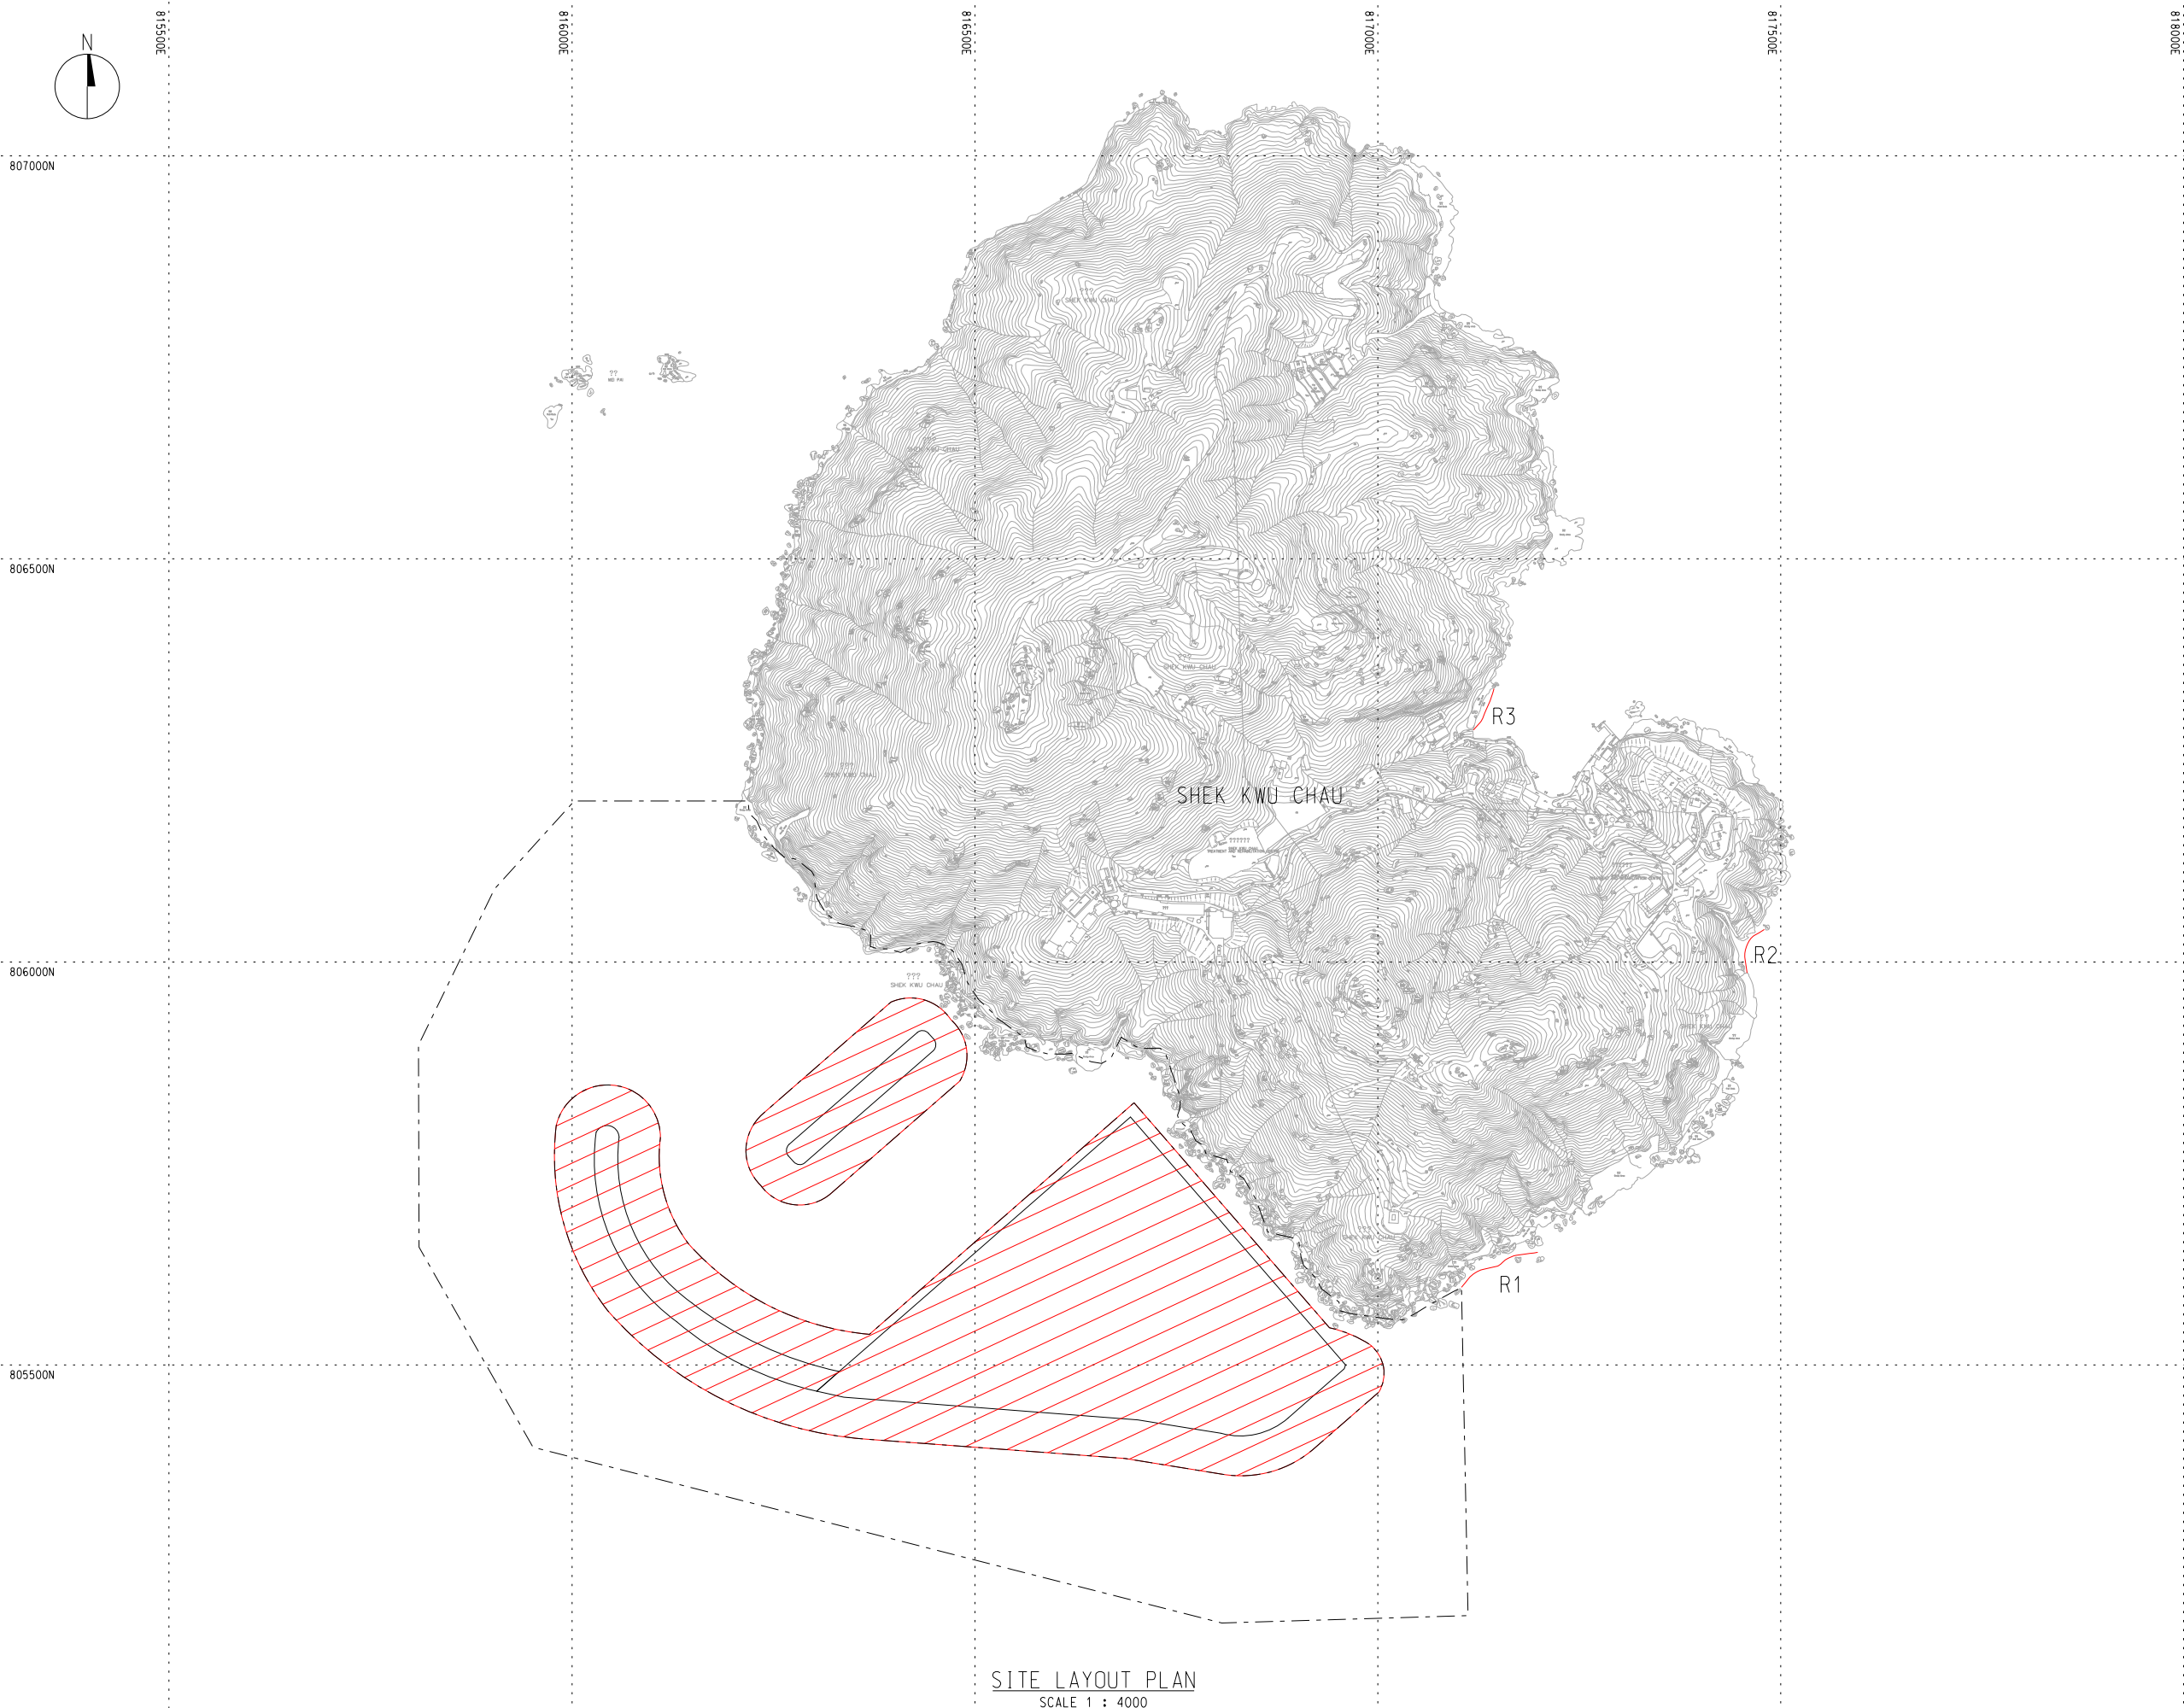
Figure 4 Locations of REA Transects at Proposed Recipient Sites R1, R2 and R3

- LEGEND:
- SITE BOUNDARY
 - ARTIFICIAL ISLAND AND MARITIME STRUCTURES OF IMM
 - REA TRANSECTS
 -

TITLE			INTEGRATED WASTE MANAGEMENT FACILITIES PHASE 1 REA TRANSECTS AT SITE R1, R2 AND R3		
SCALE @ A1	DRAWING NO.	REV.			
1 : 4000	EP/SP/66/12/COR/003	A

3.2.2. A 100m transect was laid at proposed recipient Site R1 (**Figure 4**). GPS coordinates of REA Transect Starting and Ending, Maximum Depth and Bottom Substrate of the site were summarized in **Table 3.4**. The average water depth of the transect was about 2.5 to 4.5 m.

3.2.5. A 100m transect was laid at proposed recipient Site R2 (**Figure 4**). GPS coordinates of REA Transects Starting and Ending, Maximum Depth and Bottom Substrate of the site were summarized in **Table 3.4**. The average water depth of the transect was about 3 to 4 m.

3.2.8. A 100m transect was laid at proposed recipient Site R3 (**Figure 4**). GPS coordinates of REA Transect Starting and Ending, Maximum Depth and Bottom Substrate of the site were summarized in **Table 3.4**. The average water depth of the transect was about 2.5 to 4 m.

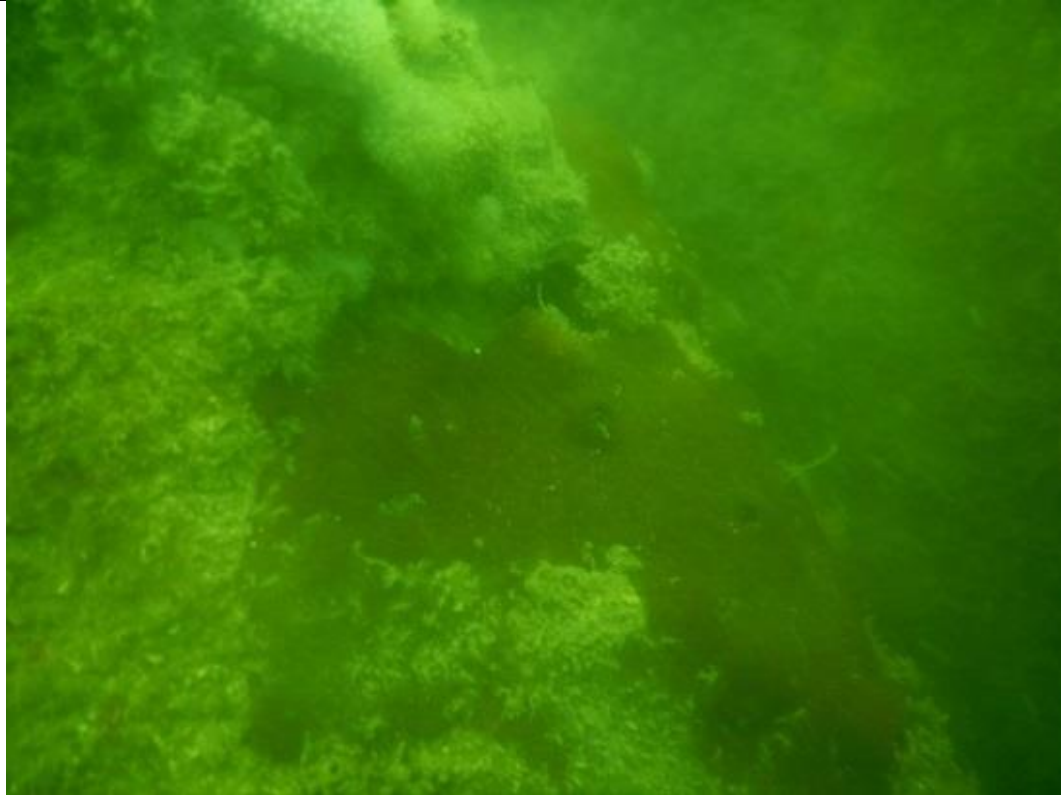
Photo 10. *Coscinarea* sp. at Suggested Recipient Site R3

3.2.10. This site supported a sparse and patchy cover (~5%) of hard corals. In general, the health conditions of corals are in fair condition. Except for the uncommon coral *Coscinaraea sp.*, all the recorded coral colonies grow on the boulders and rocks surfaces. All the recorded coral colonies grow on the boulders and rocks surfaces. Except for the uncommon coral *Coscinaraea sp.*, all coral colonies recorded along the transect are common coral species in Hong Kong water. Photos of the site and representative corals are shown in **Photo Plates 2**.

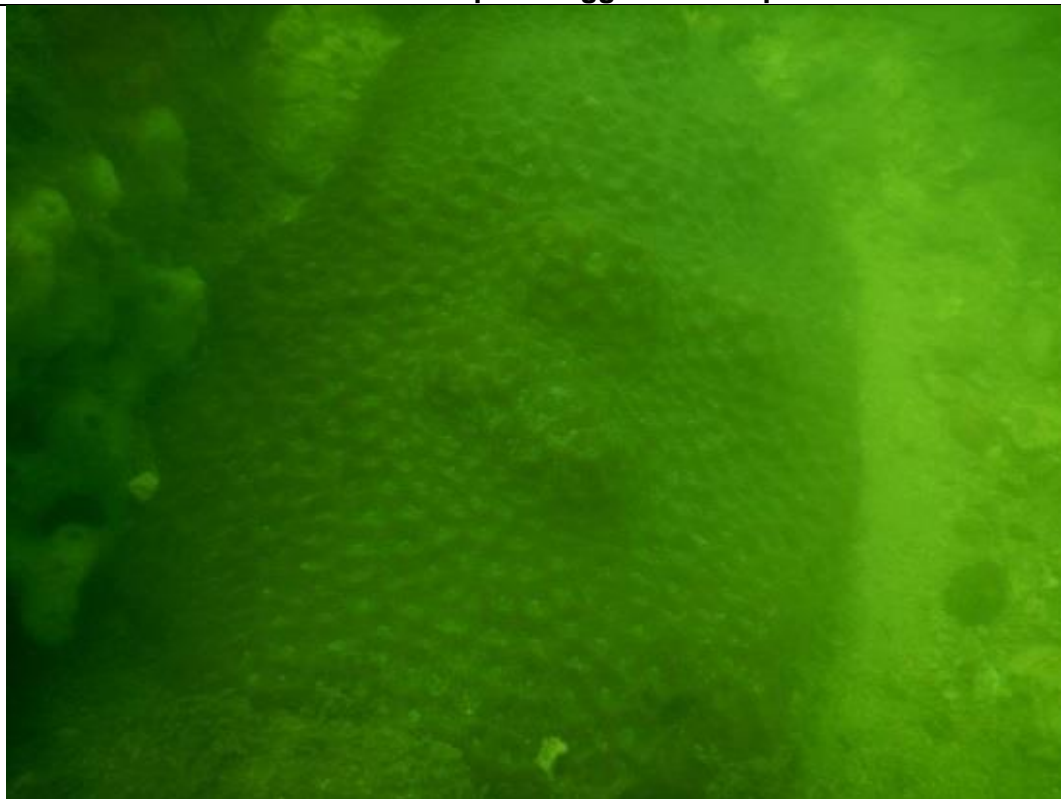
Photo 11. *Favites chinensis* at Suggested Recipient Site R3

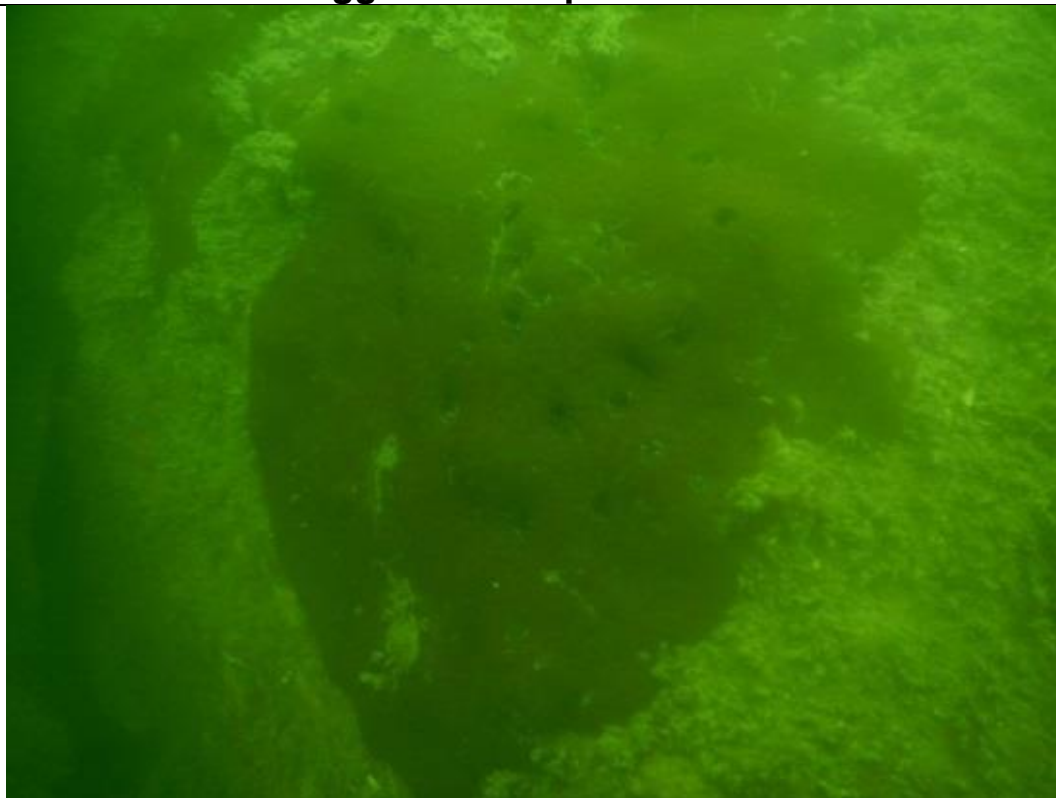
Photo 12. *Psammocora superficialis* at Suggested Recipient Site R3

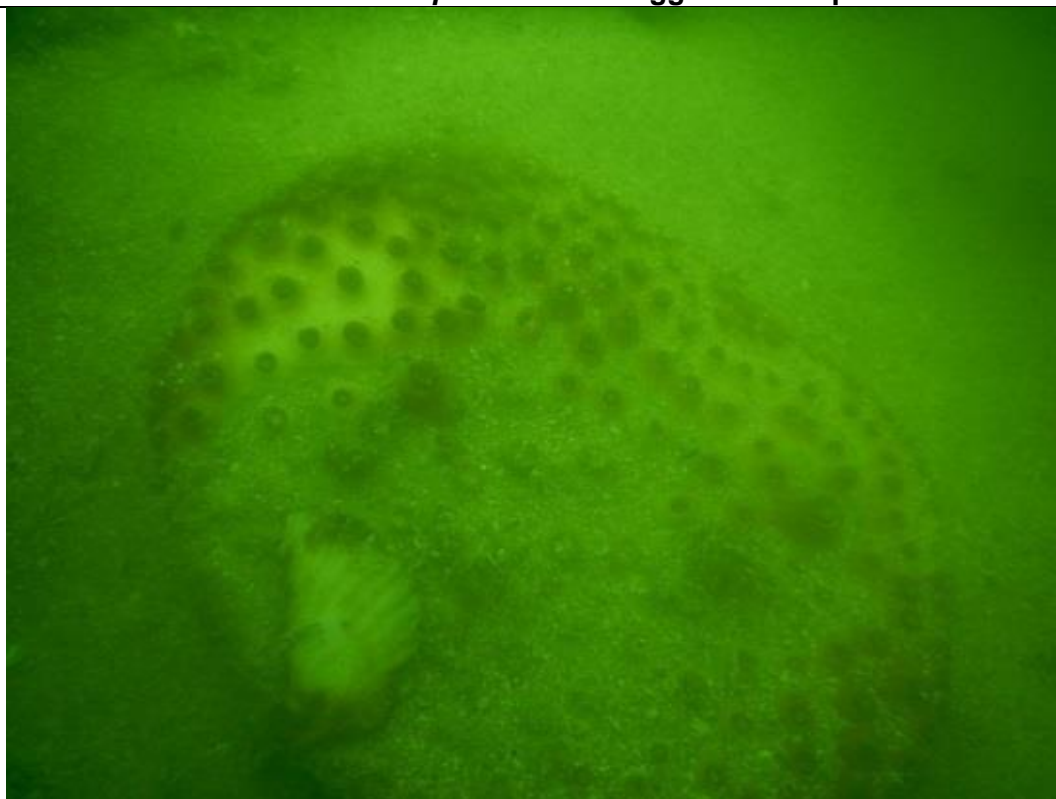
Photo 13. *Turbinaria peltata* at Suggested Recipient Site R3
