**Service Contract No.
WD/03/2023 Hung Shui
Kiu/Ha Tsuen New
Development Area
Second Phase
Development -
Environmental Team**

10th Monthly Environmental
Monitoring and Audit(EM&A) Report
(August 2025)

Revision: 2

2025-09-11

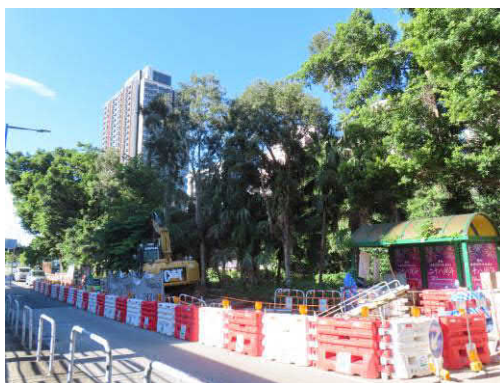
Plate 6.1 Site Condition(s) of Egretry Survey during the Reporting Month

- 6.2.5 Pipe laying works of another project at Hung Shui Kiu Main Street has commenced on 29 April 2025 and it is expected to complete on 14 July 2027. Increased noise and heavy vehicles were observed but the egretty has not been significantly disturbed by the pipe laying works.

Pipe Laying Works of another project at Hung Shui Kiu Main Street

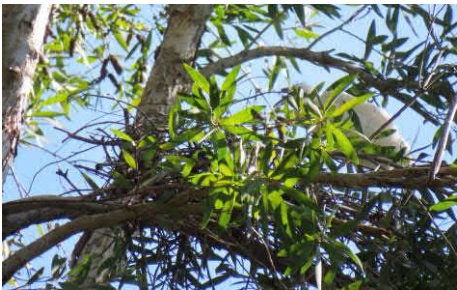
No.	Ardeid Species	Nesting Substratum	Key observations	Representative Photo
1	Little Egret	<i>Melaleuca cajuputi</i> subsp. <i>Cumingiana</i>	1 fledgling nearby

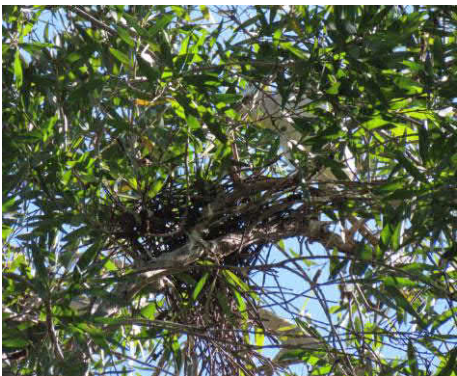
2	Little Egret	<i>Melaleuca cajuputi</i> subsp. <i>Cumingiana</i>	1 fledgling nearby

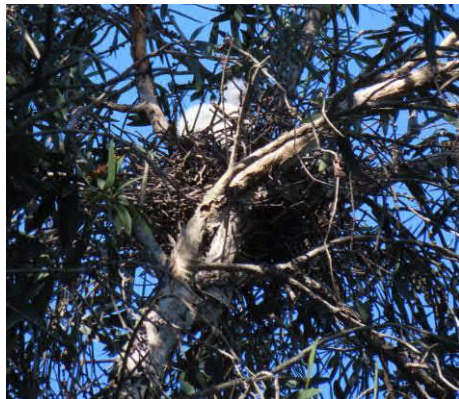
No.	Ardeid Species	Nesting Substratum	Key observations	Representative Photo
3	Little Egret	<i>Melaleuca cajuputi</i> subsp. <i>Cumingiana</i>	2 nestlings
