**Service Contract No.
WD/03/2023 Hung Shui
Kiu/Ha Tsuen New
Development Area
Second Phase
Development -
Environmental Team**

7th Monthly Environmental
Monitoring and Audit (EM&A) Report
(May 2025)

Revision: 2

2025-06-13

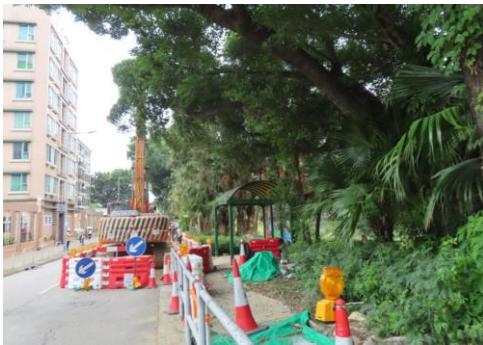
Plate 6.1 Site Condition(s) of Egretry Survey during the Reporting Month

- 6.2.7 Photo(s) of the site condition(s) where the egretty survey was undertaken on 26 May 2025 are presented in **Plate 6.1**. The status and representative photo of each active nest recorded are detailed in **Table 6.1**.

New Pipe Laying Works of another project at Hung Shui Kiu Main Street

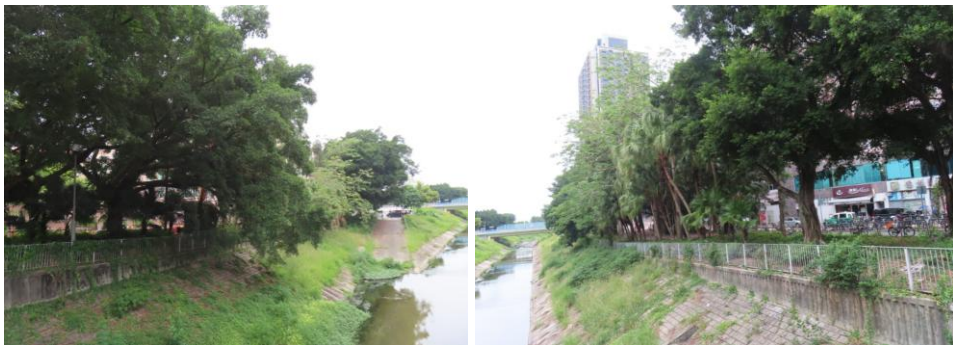
The full view of the colony / trees utilized by ardeids on both side of the drainage channel.

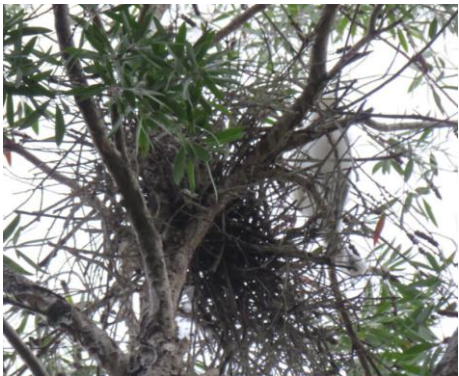
| No. | Ardeid Species | Nesting Substratum | Key observations | Representative Photo |
|---|---|--|---|--|
| 2 | Little Egret | <i>Melaleuca cajuputi</i> subsp. <i>Cumingiana</i> | 1 fledgling near the nest | |

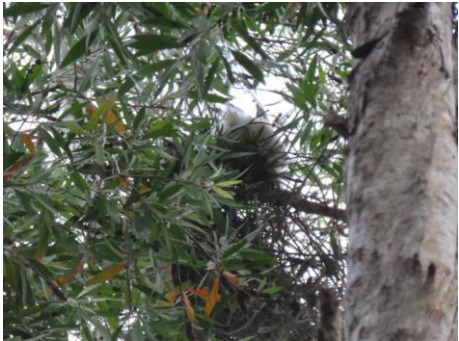
| No. | Ardeid Species | Nesting Substratum | Key observations | Representative Photo |
|---|---|--|---|--|
| 3 | Little Egret | <i>Melaleuca cajuputi</i> subsp. <i>Cumingiana</i> | 2 nestlings | |

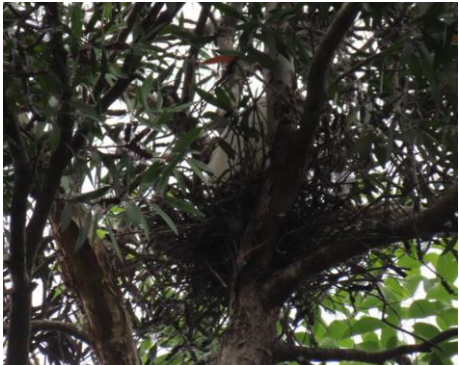
| No. | Ardeid Species | Nesting Substratum | Key observations | Representative Photo |
|---|---|--|---|--|
| 5 | Little Egret | <i>Melaleuca cajuputi</i> subsp. <i>Cumingiana</i> | 1 adult sitting on nest | |

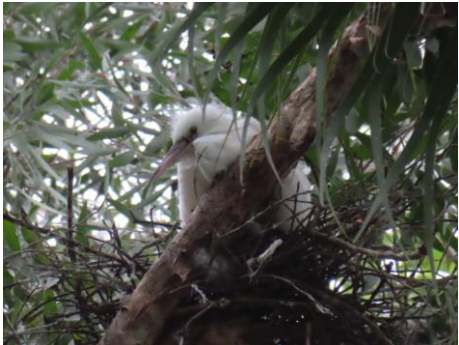
| No. | Ardeid Species | Nesting Substratum | Key observations | Representative Photo |
|---|---|--|---|--|
| 6 | Little Egret | <i>Melaleuca cajuputi</i> subsp. <i>Cumingiana</i> | 1 fledgling | |

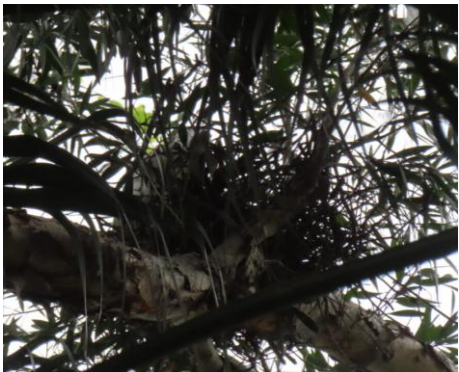
| No. | Ardeid Species | Nesting Substratum | Key observations | Representative Photo |
|---|---|--|---|--|
| 7 | Little Egret | <i>Melaleuca cajuputi</i> subsp. <i>Cumingiana</i> | 1 adult sitting on nest | |

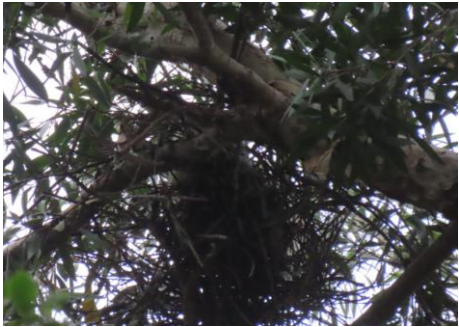
| No. | Ardeid Species | Nesting Substratum | Key observations | Representative Photo |
|---|---|--|---|--|
| 8 | Little Egret | <i>Melaleuca cajuputi</i> subsp. <i>Cumingiana</i> | 1 adult sitting on nest | |

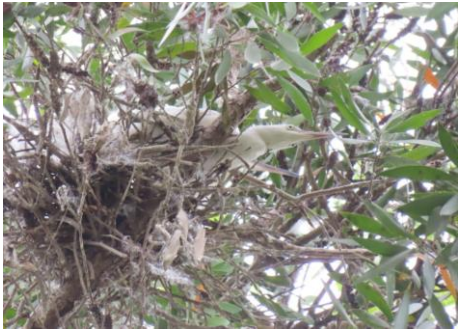
| No. | Ardeid Species | Nesting Substratum | Key observations | Representative Photo |
|---|---|--|---|--|
| 9 | Little Egret | <i>Melaleuca cajuputi</i> subsp. <i>Cumingiana</i> | 2 fledglings | |

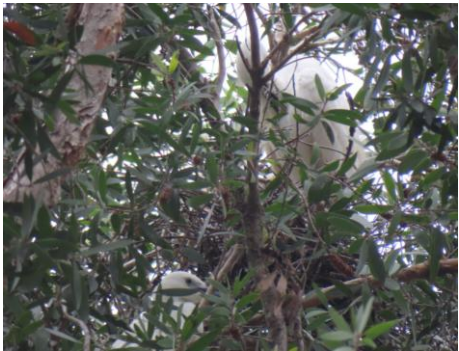
| No. | Ardeid Species | Nesting Substratum | Key observations | Representative Photo |
|---|---|--|---|--|
| 10 | Little Egret | <i>Melaleuca cajuputi</i> subsp. <i>Cumingiana</i> | 1 adult sitting on nest | |

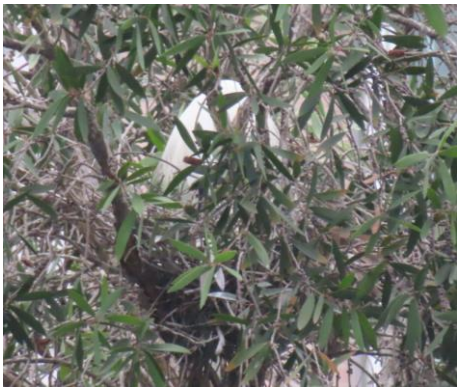
| No. | Ardeid Species | Nesting Substratum | Key observations | Representative Photo |
|---|---|--|---|--|
| 11 | Little Egret | <i>Melaleuca cajuputi</i> subsp. <i>Cumingiana</i> | 1 adult sitting on nest | |

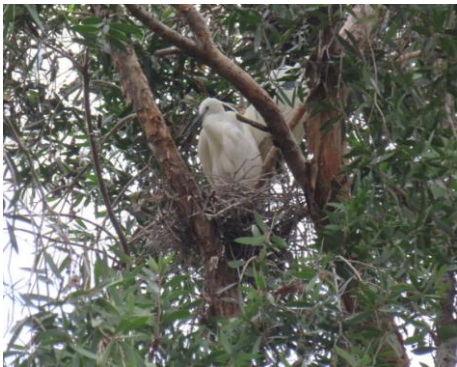
| No. | Ardeid Species | Nesting Substratum | Key observations | Representative Photo |
|---|---|--|---|--|
| 12 | Little Egret | <i>Melaleuca cajuputi</i> subsp. <i>Cumingiana</i> | 2 adults sitting on nest | |

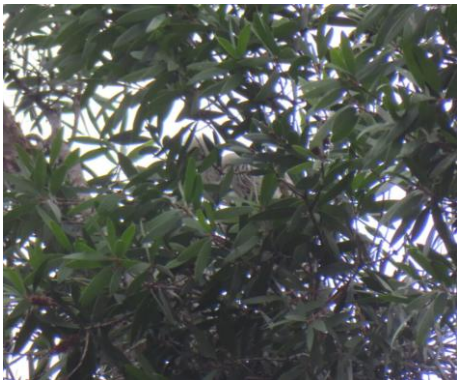
| No. | Ardeid Species | Nesting Substratum | Key observations | Representative Photo |
|---|---|--|---|--|
| 13 | Little Egret | <i>Melaleuca cajuputi</i> subsp. <i>Cumingiana</i> | 1 nestling | |

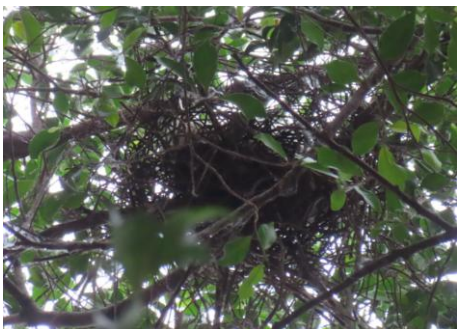
| No. | Ardeid Species | Nesting Substratum | Key observations | Representative Photo |
|---|---|--|---|--|
| 14 | Little Egret | <i>Ficus microcarpa</i> | 1 adult sitting on nest | |

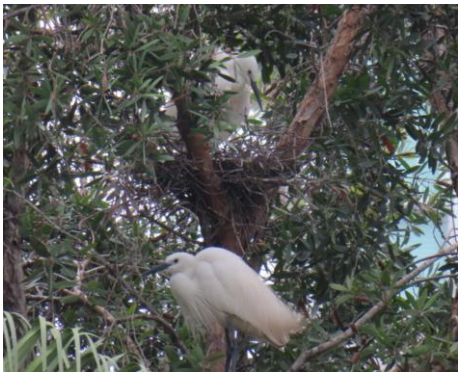
| No. | Ardeid Species | Nesting Substratum | Key observations | Representative Photo |
|---|---|--|--|--|
| 15 | Little Egret | <i>Melaleuca cajuputi</i> subsp. <i>Cumingiana</i> | 1 adult sitting on nest and 1 adult nearby | |

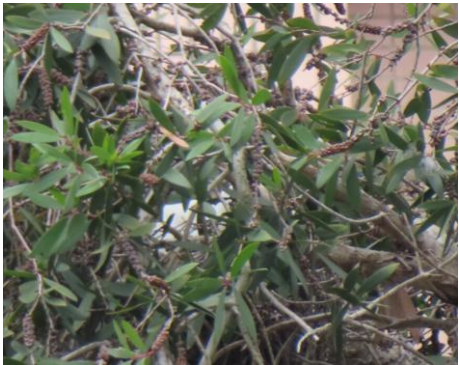
| No. | Ardeid Species | Nesting Substratum | Key observations | Representative Photo |
|---|---|--|--|--|
| 16 | Little Egret | <i>Melaleuca cajuputi</i> subsp. <i>Cumingiana</i> | 1 adult sitting on nest | |

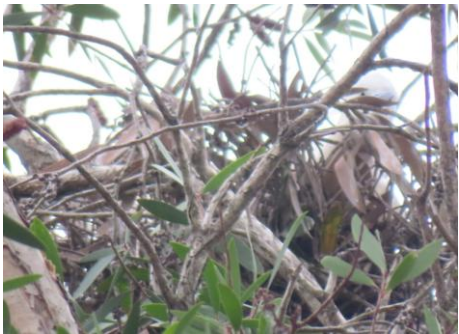
| No. | Ardeid Species | Nesting Substratum | Key observations | Representative Photo |
|---|---|--|--|--|
| 17 | Little Egret | <i>Melaleuca cajuputi</i> subsp. <i>Cumingiana</i> | 1 adult sitting on nest | |

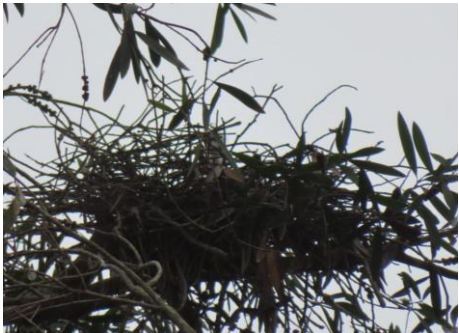
| No. | Ardeid Species | Nesting Substratum | Key observations | Representative Photo |
|---|---|--|--|--|
| 18 | Little Egret | <i>Melaleuca cajuputi</i> subsp. <i>Cumingiana</i> | 1 nestling | |
